San Angelo, TX

MONTHLY REPORT OF HYDROLOGIC CONDITIONS

November 2011

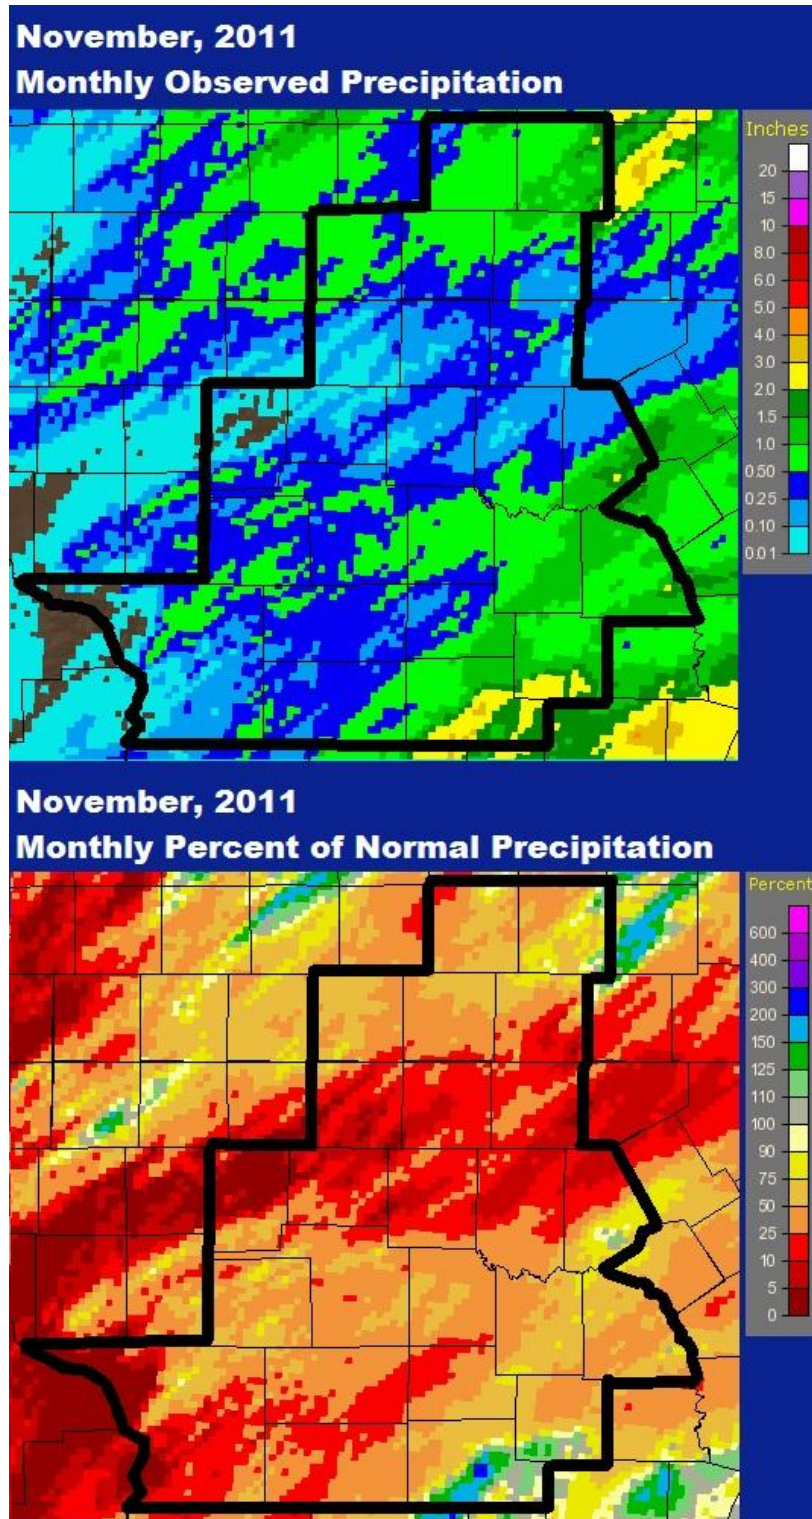
The total monthly precipitation estimate and percent of normal precipitation for November across the San Angelo HSA is depicted below.
